Inspection Report: Kensington Gold Mine

Tongass National Forest, Minerals Group
8510 Mendenhall Loop Road
Juneau, Alaska 99801
(907) 789-6276 – office
(907) 586-8808 – fax

Date of Inspection: Thursday, May 30, 2013
Date of Report: Wednesday, June 05, 2013
USDA Forest Service Inspector: David Schmerge

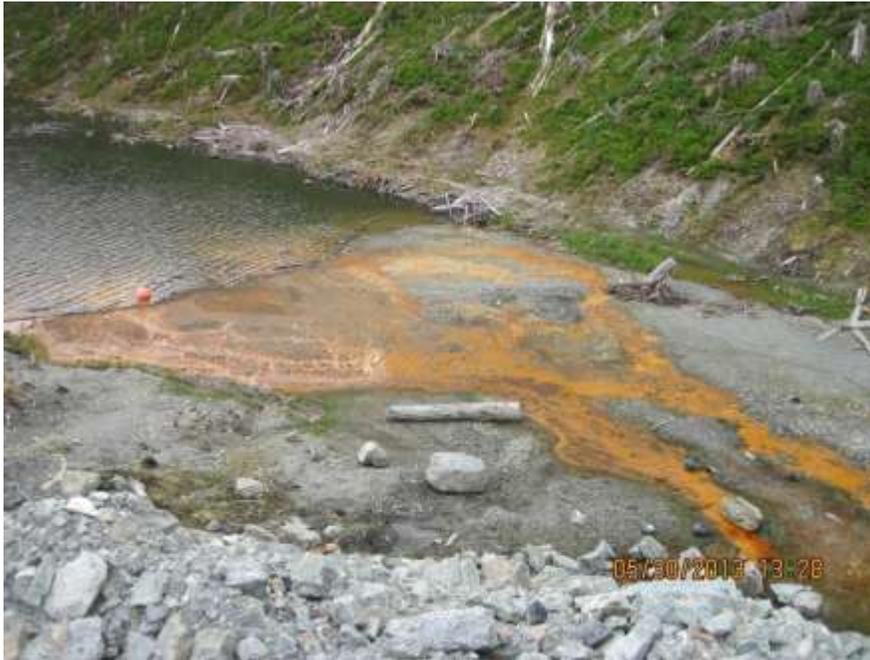
Acid rock drainage (ARD) is occurring at the north end of Lower Slate Lake (photos 1 and 2). I sampled the site at multiple points with pH test strips, and the pH was usually 4 or 5, with one point as low as 2. Coeur collected water samples and sent them to the lab for analysis. The ARD is coming from rock that was excavated during the phase 2 construction of the dam last summer. There are two types of rock that were excavated: graphitic phyllite and chloritic phyllite. The graphitic phyllite has acid generating potential and the chloritic phyllite does not. Most of the graphitic phyllite was moved to the north mud dump and placed in a temporary containment cell, and the chloritic phyllite was stockpiled at the north end of Lower Slate Lake. It is hypothesized that some of the graphitic phyllite was mistakenly placed into the stockpile at the north end of the lake instead of the containment cell. Coeur has dug several holes into the stockpile (photo 3), and sent samples to the lab for analysis to determine the quantity of graphitic phyllite that may be there. A preliminary estimate is that 11,000 to 17,000 tons of rock may need to be removed in

Photo 1. Acid Rock Drainage was recently discovered at the north end of Lower Slate Lake.

1. As soon as possible, submit to the Forest Service and ADEC the lab results of the water quality samples and the rock samples taken from the north end of Lower Slate Lake.
2. Submit to the Forest Service and ADEC a plan to mitigate the ARD at Lower Slate Lake.
3. The spring at the Comet portal should be diverted away from the waste rock pile.
4. The waste rock in the Ophir Creek floodplain should be removed and the silt fence that has been nearly buried should be re-established.
5. The debris at the base of the berms of ponds 1 and 2 should be cleaned up.

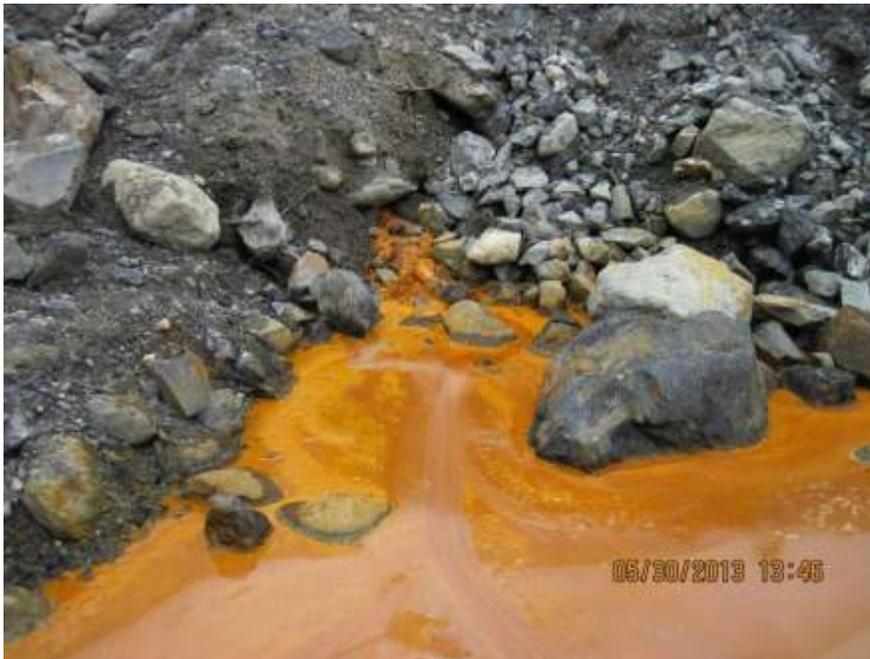
Photo 2. The pH of this seep was about 4.

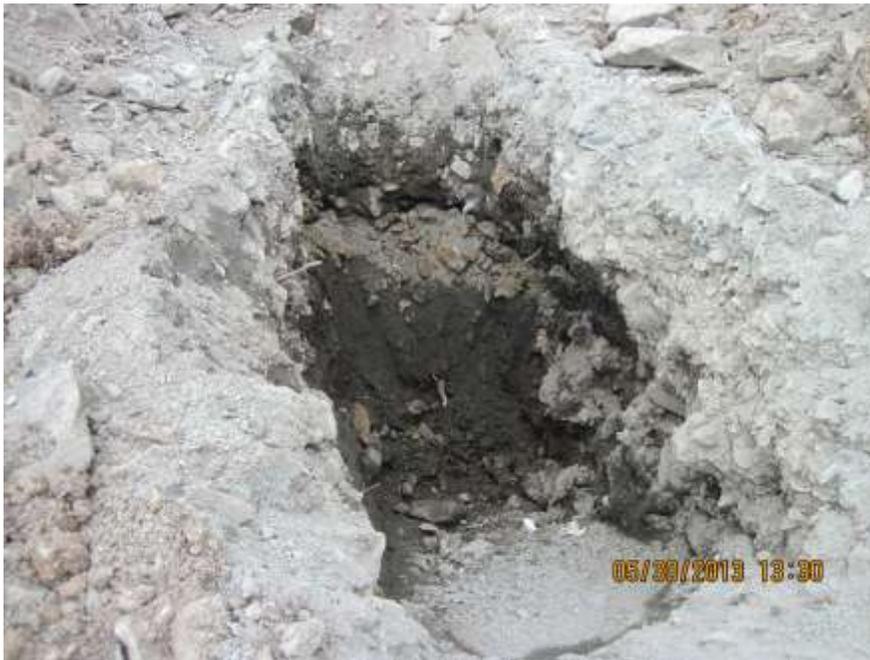
Photo 3. Several holes like this one have been dug to determine the amount of graphitic phyllite that is at the site.

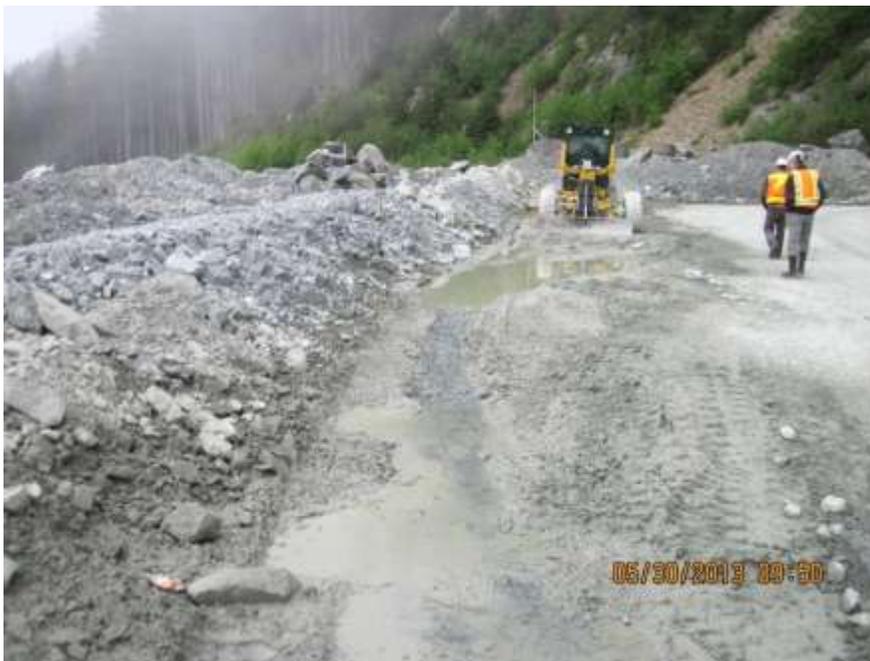
A double berm has been created to prevent further dumping of mine sediment into Ophir Creek (photo 4). A spring was observed near the portal, and water was running across the waste rock pile and down the road (photo 5).

Photo 4. A double berm has been constructed on the top of the waste rock pile to prevent the dumping of material into Ophir Creek.

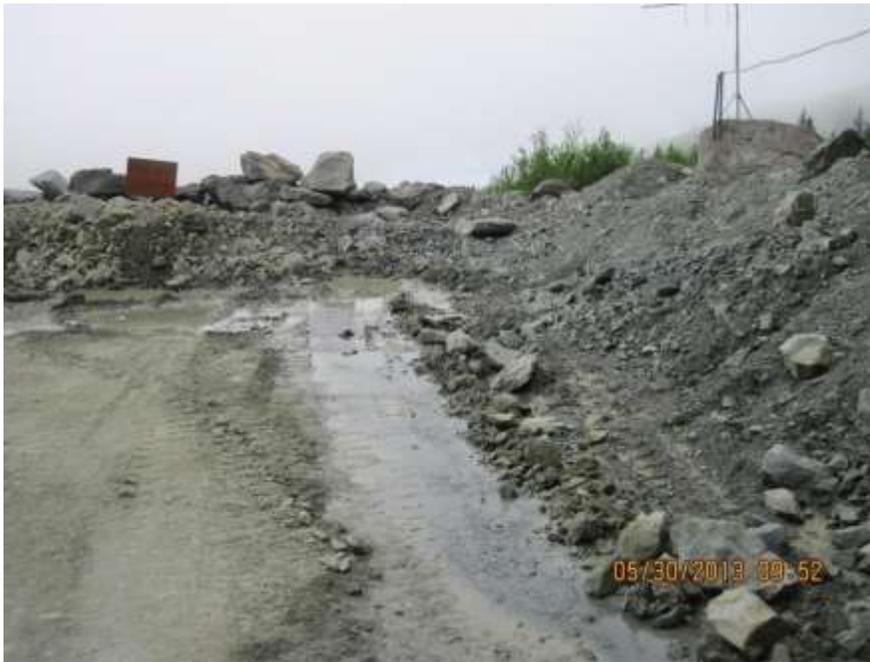
Photo 5. Water from a spring near the mine portal is running across the waste rock pile and down the road.

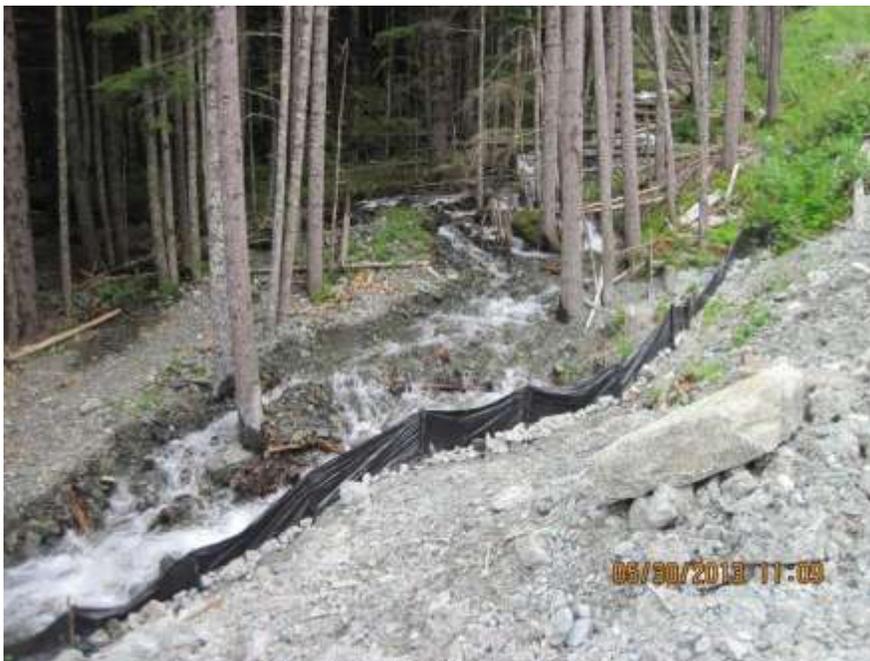
The silt fence was moved so that Ophir Creek is no longer running over it (photo 6). No significant accumulation of mine sediment was observed. There is an old silt fence nearby that is nearly buried by waste rock that has rolled down the pile and onto the Ophir Creek floodplain (photo 7).

Photo 6. Ophir Creek is no longer running through the silt fence.

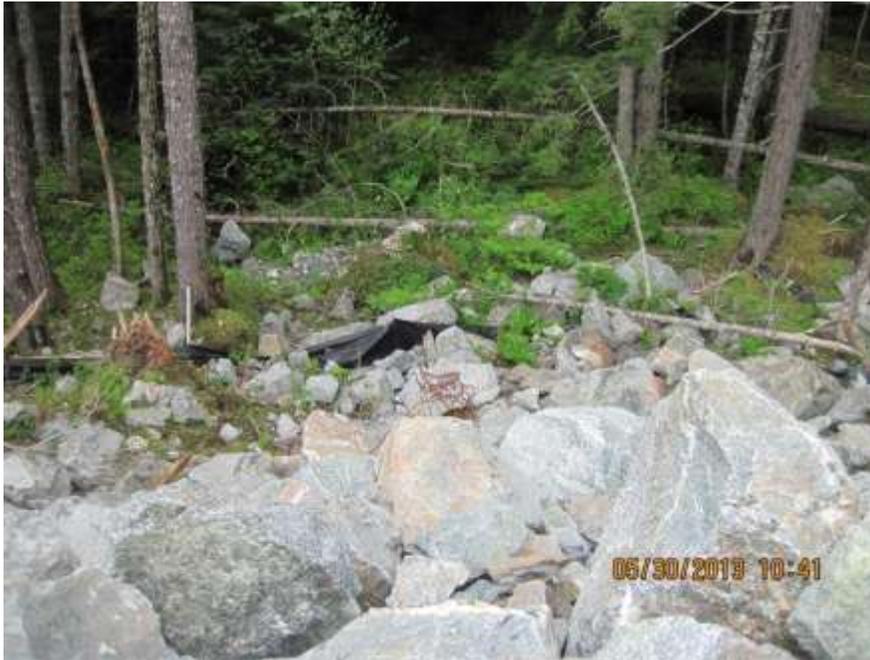
Photo 7. Waste rock has rolled down the pile and onto the Ophir Creek floodplain. This old silt fence is nearly buried.

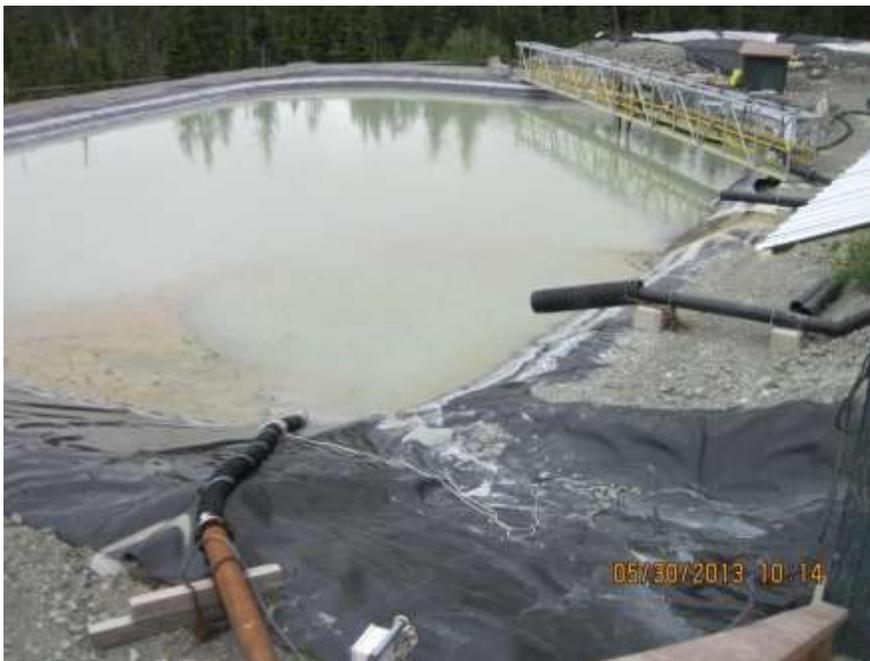
A tear in the liner of pond 2 was recently repaired. The tear was located directly below the influent pipe, and it is assumed that the tear was from stress due to the sediment and water loading. The pond was drained and the sediment was removed in order to repair the tear. A piece of flexible pipe was fitted on the influent pipe to eliminate direct impact onto the liner from the incoming water and sediments (photo 8). We walked the perimeter of ponds 1 and 2 to see if there was any visible seepage due to the recent liner tear. None was found, but there was debris such as a bucket and foam from silt curtain floats in the wetlands and shrubs at the base of the berms.

Photo 8. Flexible pipe has been fitted onto the influent pipe of pond 2 to prevent tears in the liner caused by inflowing mine water and sediment.
